## **Bubbles Because Of Bad Vacuuming, EVA Laminated Glass Safety Glazing Case Study and Solutions By Peter Lin**

The bubbles of laminated glass with EVA interlayer film happened because of bad vacuuming, and the bad vacuuming was because the vacuum pump was completely choked.

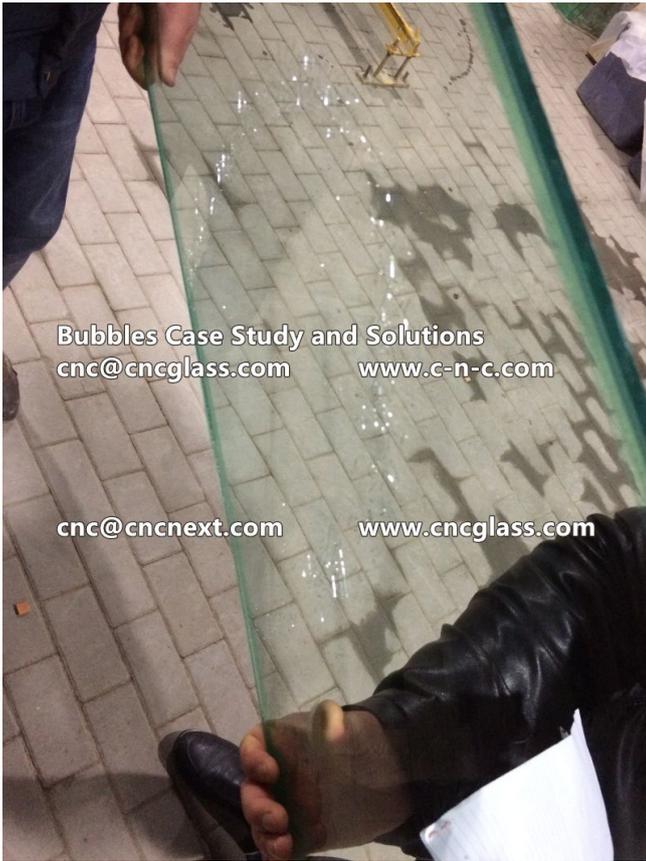
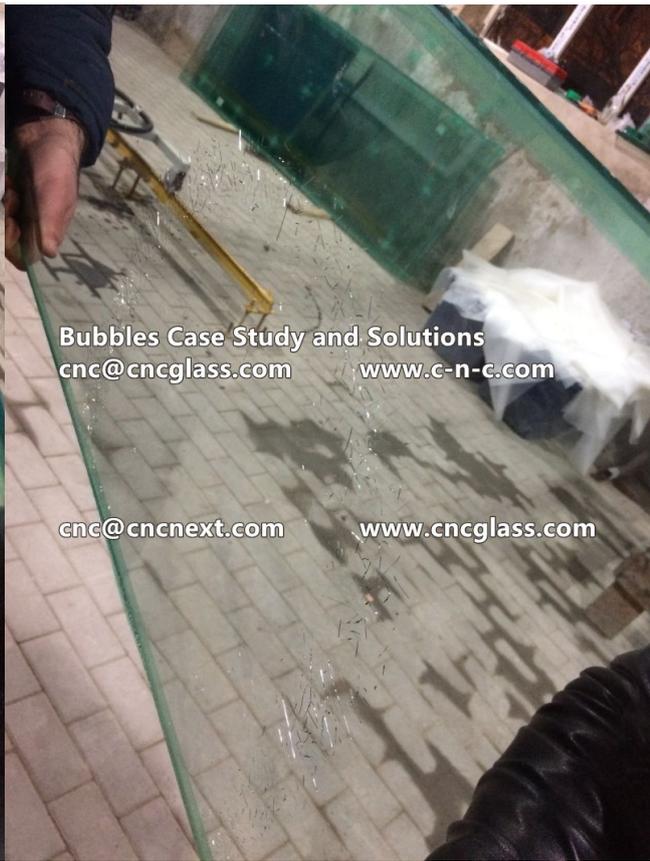
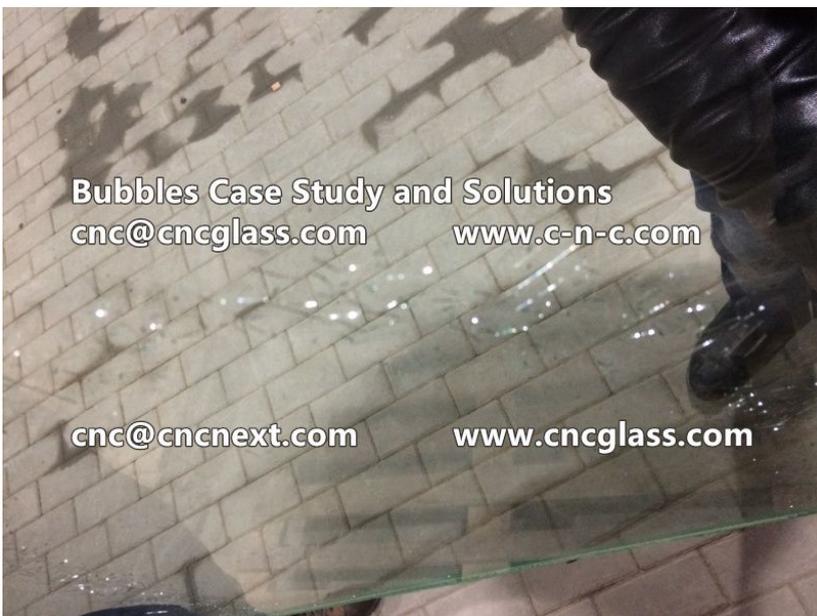
Following are the photos of the failed laminated glass with bubbles:

Our first analysis is: The vacuuming system is not strong enough. According the photos of laminated glass you sent to us, the bubbles area was big and gathered in one place, and close to edges, because the vacuuming is not strong enough to vacuuming them out. Please check your vacuuming value and the vacuum pump to see if it's working well.

There are wrinkles mostly and they are close to the edges. You are right .

We checked the vacuum pump and the Filter was completely choked. Today we cleaned it and will load some glasses in order to control the process. Now the problem is well solved.

The solutions is to clean the vacuum pump and renew it.
